Manhole Inspection Summary

Manhole # S31CC_031MH

Insp Date: **2/7/07 9:13 AM**

Location Address: **PRESTON ST**

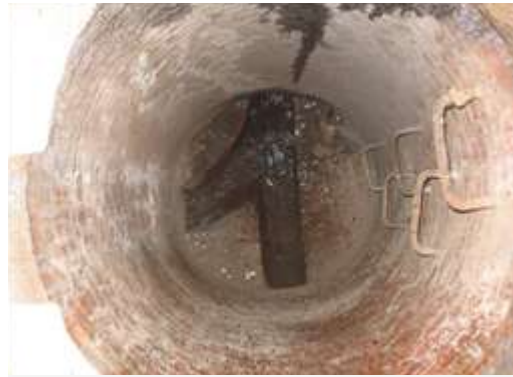
Top View

Bench and Channel debris. Corroded steps.

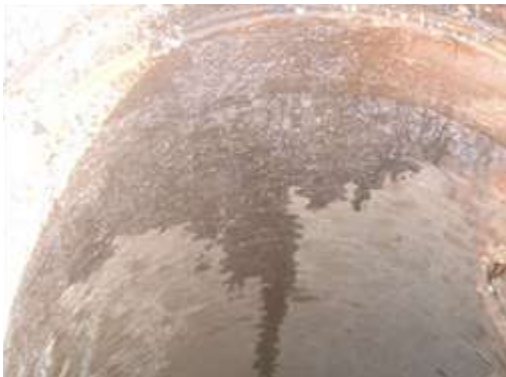
Defect

Frame leaks. Adjustment infiltration.

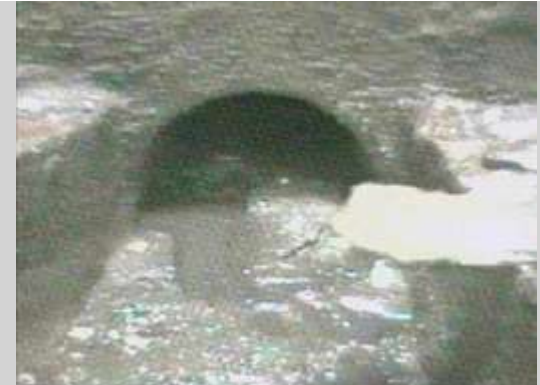
10 in. Circular Gravity Sewer Pipe Out @ 12 O'Clock

Deposits: ☐ None ☒ **Mud** ☐ Sludge ☒ **Debris** ☐ Grease

Silt Depth: **2** (in.) Deposits Extent: **Light**

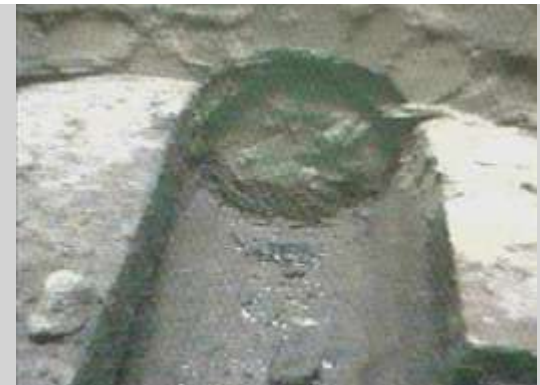
10 in. Circular Gravity Sewer Pipe In @ 6 O'Clock

CAPPED.

Connects To: **Stub connection / abandoned**

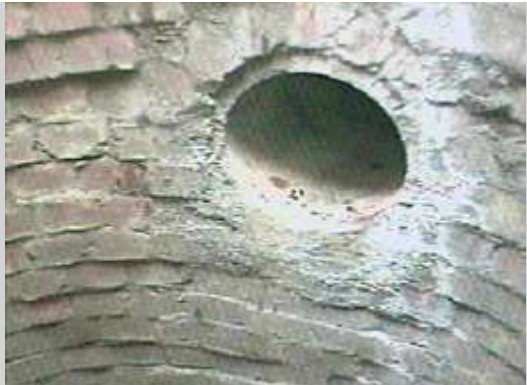
Pipe In @ 9 O'Clock

Deposits: ☐ None ☒ **Mud** ☐ Sludge ☒ **Debris** ☐ Grease

Silt Depth: **0.5** (in.) Deposits Extent: **Light**

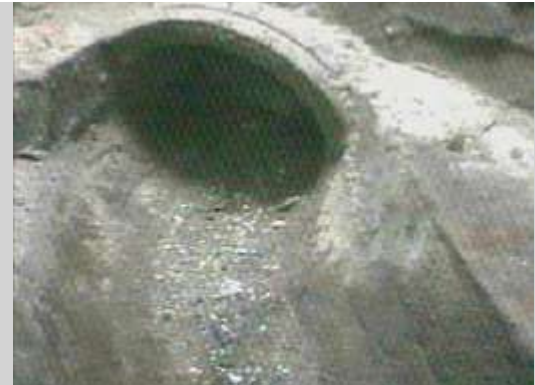
Drop In @ 9 O'Clock

Drop: **Outside** Rod and Bar

Drop Condition: **Open**
